AL SUMELAT
WATER NETWORK
VILLAGE OF AL SUMELAT, IRAQ

SIGIR PA-05-004
MARCH 15, 2006

Special Inspector General for Iraq Reconstruction

Al Sumelat Water Network Village of Al Sumelat, Iraq Synopsis

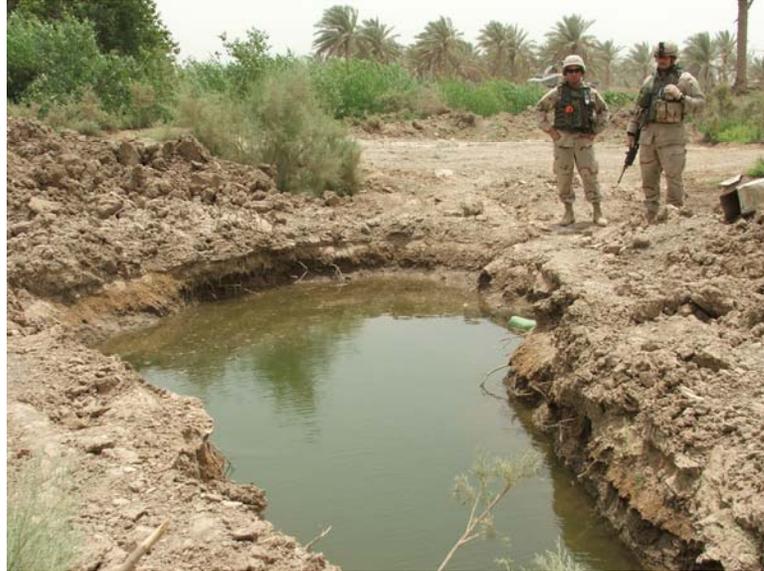
Connect new 250 mm diameter UPVC pipeline to existing 1200 mm water main
The contract required connecting the new 250 millimeter diameter UPVC pipeline to the existing 1200 millimeter water main. Observations during the site visit could not verify the new connection had been completed. An open excavation was found at the location of the connection (Figure 1, point A). The excavated pit was filled with water (Site photo 1) and piping could not be located beneath the water.

Site Photo 1: Pipeline point A, showing recent excavation

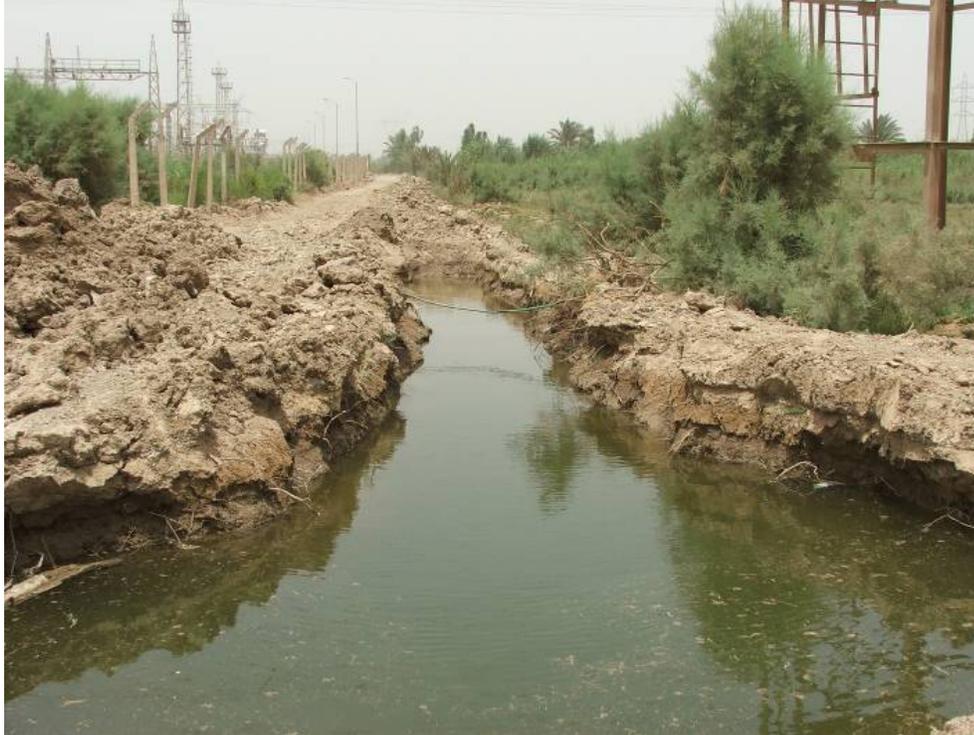
Point A to B: The approximate length of the pipeline from point A to point B (see the locator map in Figure 1 on page 4) is 840 meters. Disturbed soil leading in the direction of the pipeline route was observed from point A. The disturbed soil appeared to be the result of a recent trench excavation and subsequent backfilling of the trench (Site photo 2). It could not be determined how far this excavation continued. The starting point of the pipeline was not visibly protruding from the disturbed soils and could not be located at point A. An observation at point B leading back toward point A along the proposed pipeline path was of an open field showing no recently disturbed soil (Site photo 3). Consequently, no evidence that the pipeline had been installed between points A and B was found.

Site photo 2: Pipeline point A, leading to point B

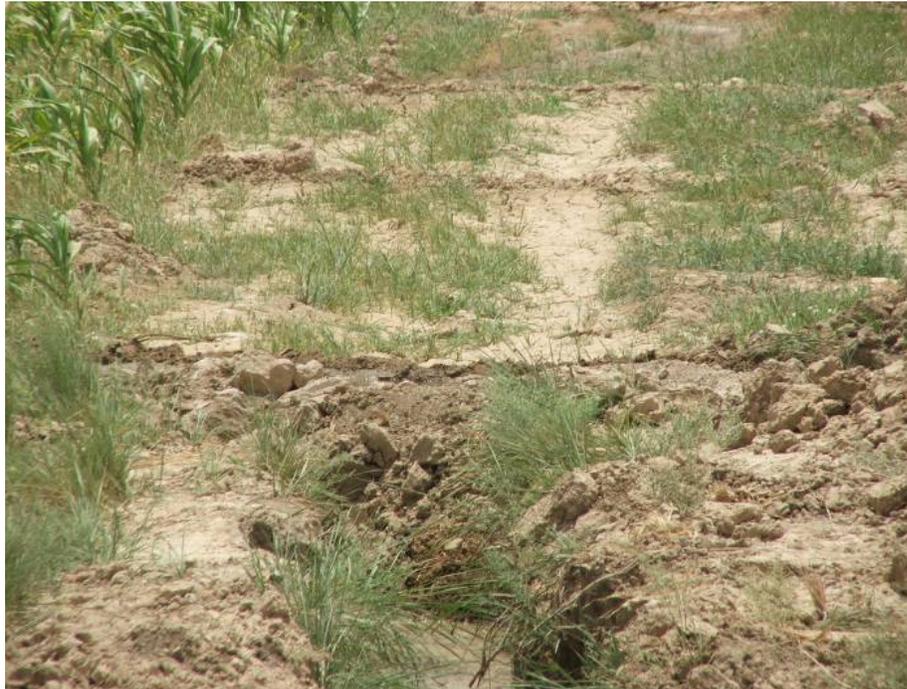
Site photo 3: Pipeline point B, leading back to point A

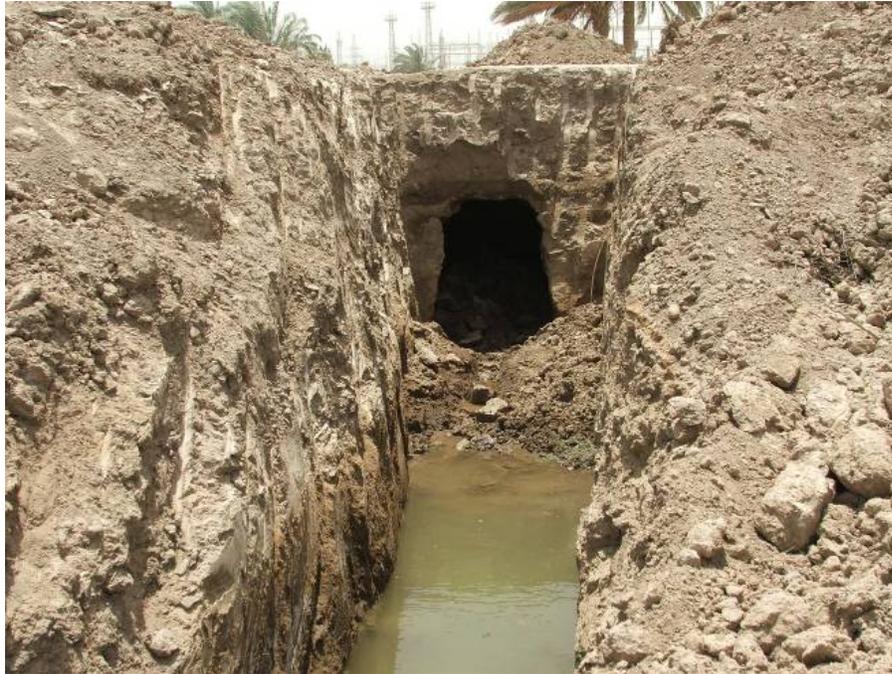
Point B: Point B on the locator map in Figure 1 on page 4 is the point at which the pipeline route crosses underneath an irrigation canal. A recently excavated tunnel approximately 1 meter by 1/2 meter was observed underneath the irrigation canal. The pipeline was not visible leading into (Site photo 4) or exiting the

tunnel. The bottom of the tunnel excavation appeared to be undisturbed soil. Consequently, no evidence that the pipeline had been installed beneath the irrigation canal was found.

Site photo 4: Point B excavated tunnel under irrigation canal

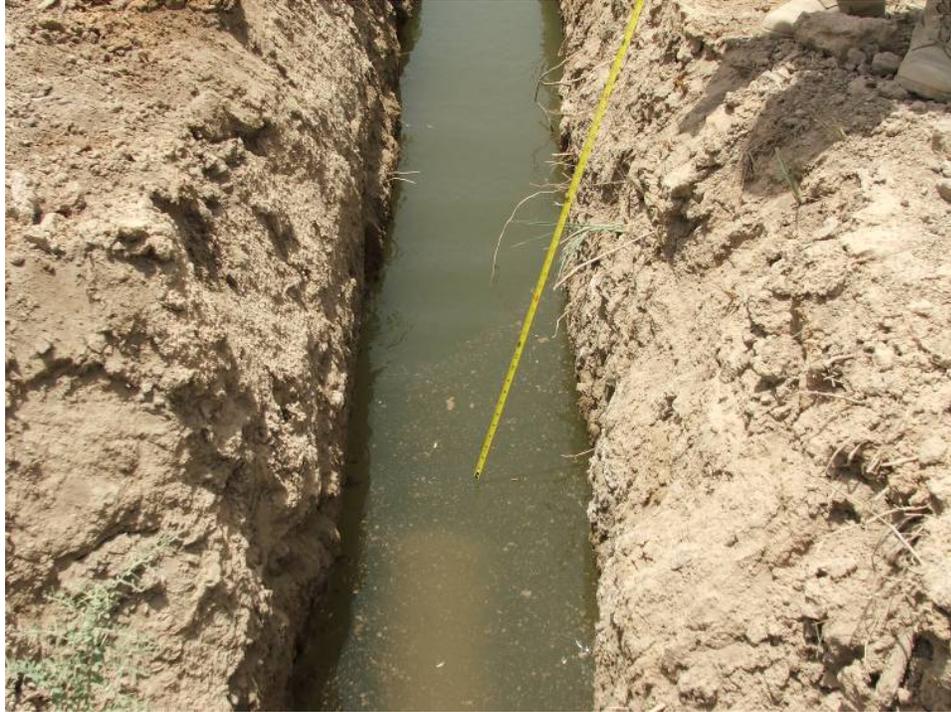
Point B to C: The approximate length of the pipeline from point B to point C (see the locator map in Figure 1 on page 4) is 1,495 meters. Uncapped endpoints of the pipeline were observed at both points B and C (Site photos 5 & 6). The pipe diameter looked to be approximately 225 millimeters, but accurate measurements were not obtained at this location. Disturbed surface soil was observed continuously between points B and C along the proposed pipeline route. The disturbed soil appeared to be the result of a recent trench excavation and subsequent backfilling of the trench. A sand base was not present at the endpoints of the pipeline. A significant amount of unconsolidated soil was observed above grade along the pipeline path. Lack of compacting during backfilling operations would result in the presence of the observed excess soil. The surface of the disturbed soil was uneven with several feet variation in height along the pipeline route. This indicates that final surface grading was not completed. It appeared, based on site assessment observations, that the pipeline had been installed between points B and C, but the pipeline installation was not consistent with contract requirements.

Site photo 5: Uncapped submerged pipe end at point B

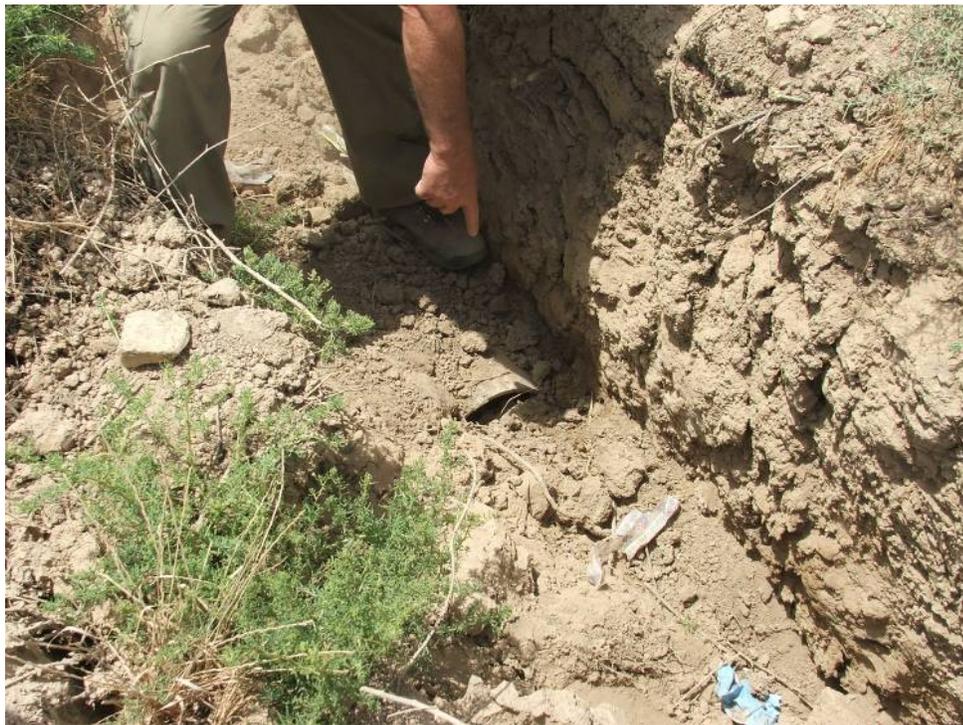
Site photo 6: Uncapped pipe end at point C

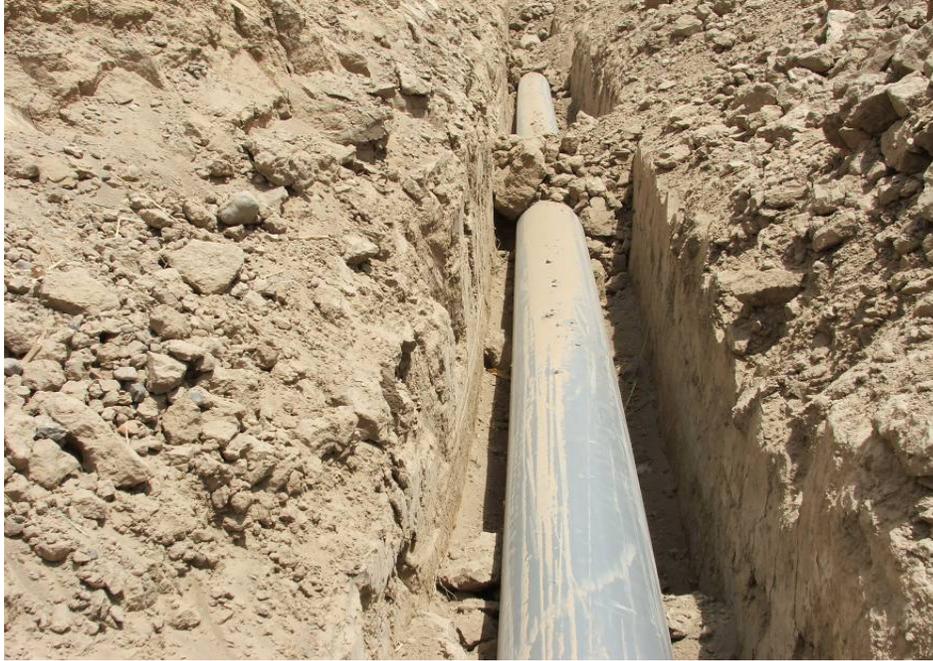
Point F to G: The pipeline leg from point F to point G (see the locator map in Figure 1 on page 4) is approximately 1,315 meters in length. Uncapped endpoints of a 225 millimeter pipeline were seen at both point F and point G. A short section of the pipeline trench, which was only partially backfilled, clearly indicated that sand base was not used (Site photo 7). Disturbed surface soil was observed along the remainder of the proposed pipeline between point F and G. The disturbed soil appeared to be the result of a recent trench excavation and subsequent backfilling of the trench. A significant amount of unconsolidated soil was observed above grade along the pipeline path. Lack of compacting during backfilling operations would result in the presence of the observed excess soil. The surface of the disturbed soil was uneven with several feet variation in height

along the pipeline route. This demonstrates final surface grading was not completed.

Site photo 7: 225 millimeter pipeline in partially back filled trench

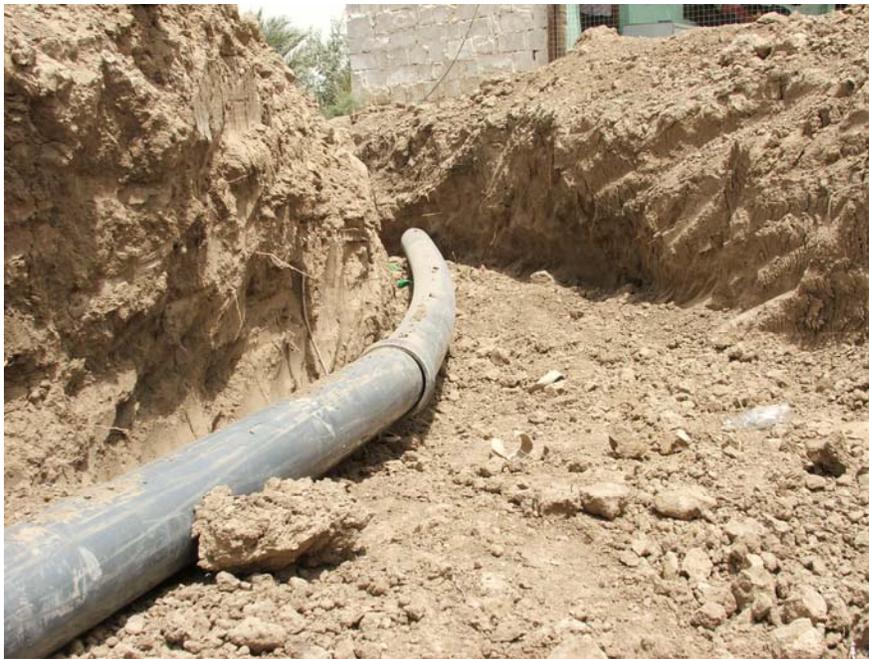
The pipeline near point G was observed to be routed around a bend without the use of an elbow fitting (Site photo 8), creating a 13 millimeter ($\frac{1}{2}$ inch) gap in the pipe connection (Site photo 9). It appeared, based on site assessment observations, that the pipeline had been installed between point F and point G, but the pipeline installation was not consistent with contract requirements.

Site photo 8: Bend in pipe

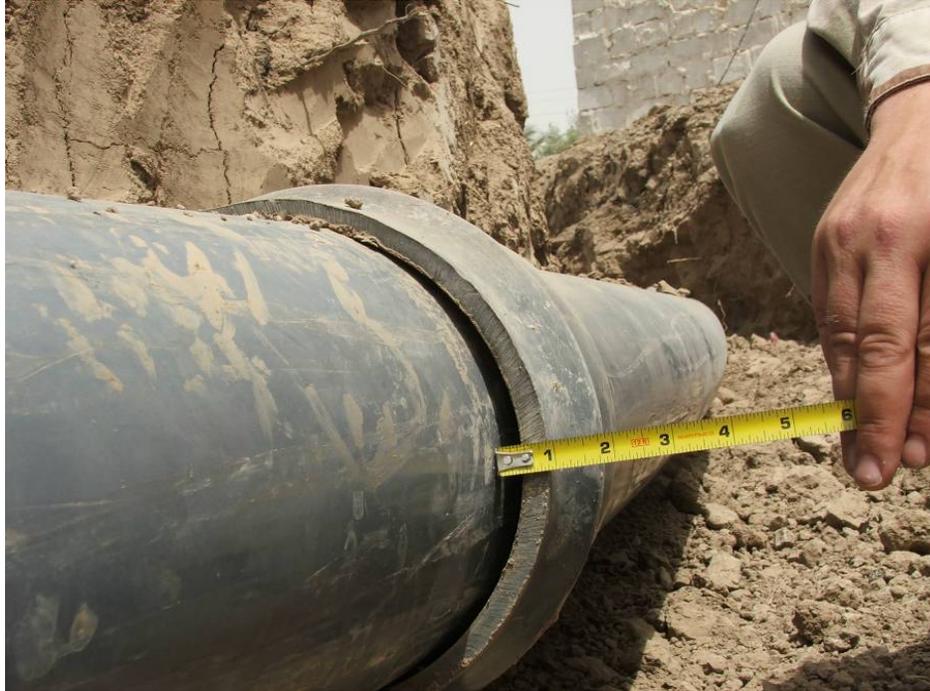
Site photo 9: ½ inch (13 millimeter) gap in pipeline joint
